Appendix B
Materials Analysis:
Paint
Mortar and Salts

Historic Building Architects, LLC

APPENDIX B - MATERIAL ANALYSIS

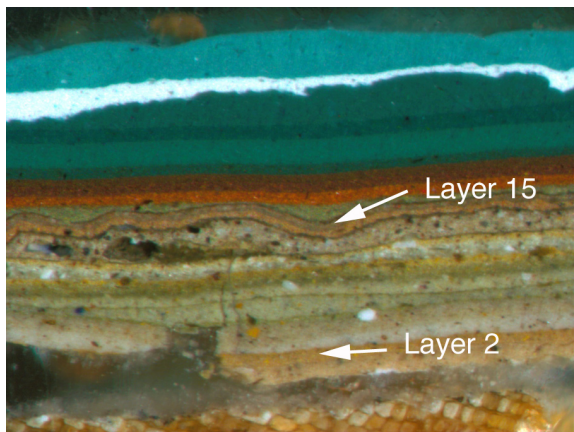
Layer 2 is the finish coat of the first painting campaign. Layer 15 shows the finish coat applied with the 1925 addition of the parish hall.

Benjamin Moore #
Brentwood 1223

Paint sample P3 taken from the Robinson window muntin seen at 80x.

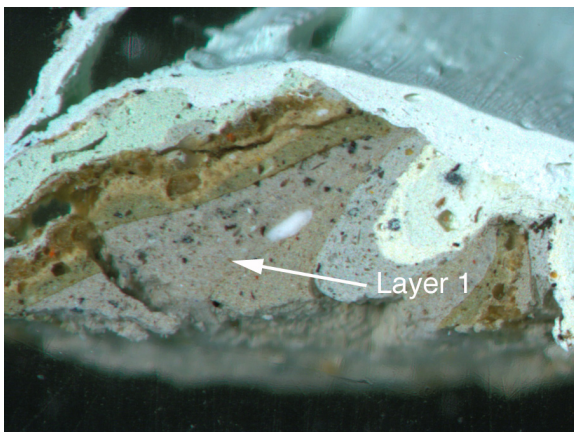
The sample floated above the wood substrate during the embedding procedure. Layer 1 was the first layer above the wood substrate.

Layer 1 is the same as layer 15 in sample P3 from the 1892 church.

Benjamin Moore #
Davenport Tan
8C-76

Sample P8 seen at 50x.

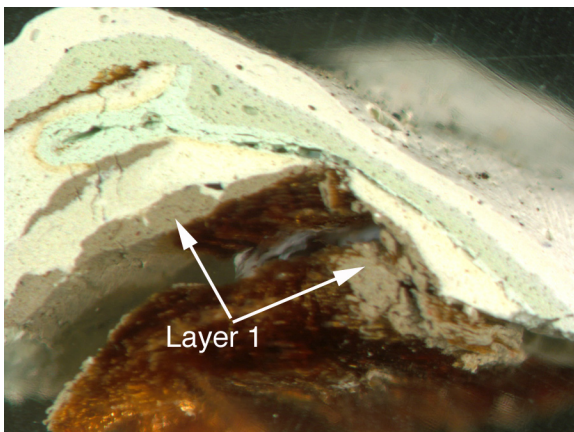
The first paint layer seen is a variation of the mauve used previously on the church and Parish Hall.

Benjamin Moore #
Greystone 1475

Sample P11 seen at 40x.

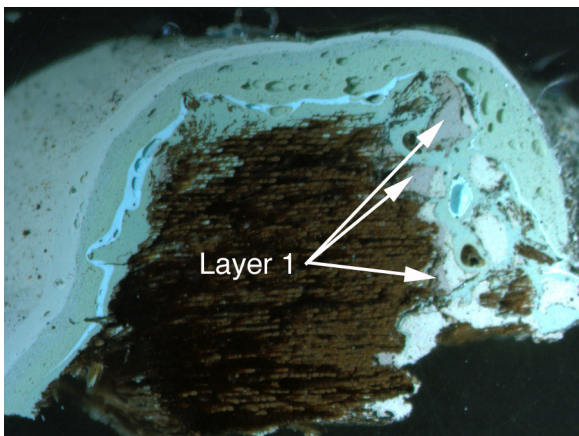
The sample was taken from the last remaining window on the east facade of Parish Hall. The lower part of window frames are particularly subject to rot due to pooling moisture and splashing as rain splatters on the sill. For this and other environmental reasons window frames are prone to paint deterioration and may need to be painted frequently. The oldest layer found in sample P14 has been broken up due to environmental reasons or aggressive cleaning. Fragments of the first layer were picked up by the paint brush during subsequent paint campaigns, and distributed throughout later paint layers.

The first layer seen in sample P14 is the same as that seen in samples taken from the 1958 Stevens Wing addition. The relatively late first paint layer may be due to the high rate of window paint deterioration.

Benjamin Moore #
Greystone 1475

Sample P14 seen
at 20x.

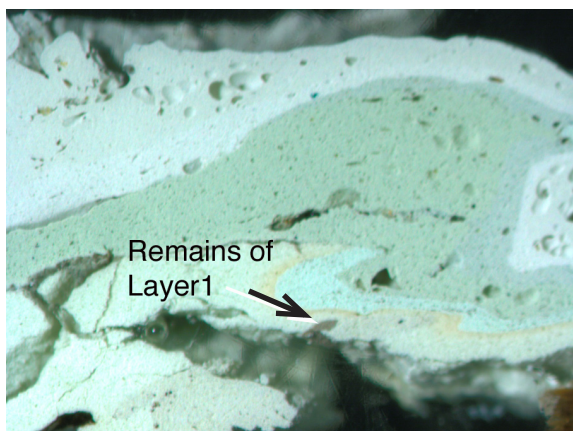
Like sample P14, the first layer has been destroyed by aggressive cleaning. A small remnant is all that is left of the first layer at the base of the sample.

Benjamin Moore #
Greystone 1475

Sample P12 seen at
30x.

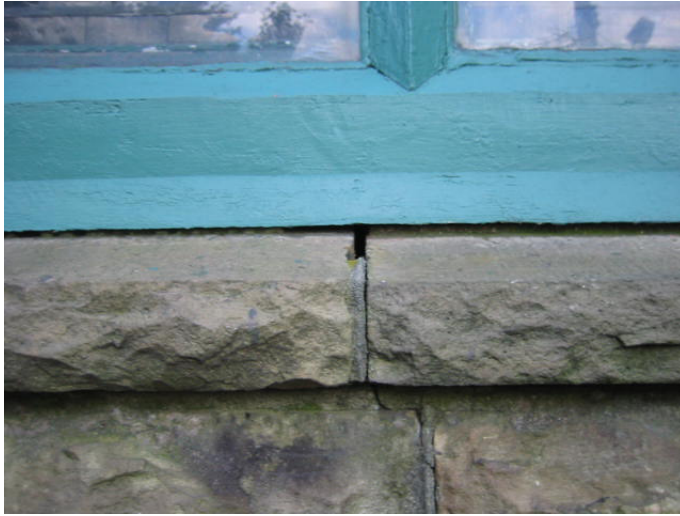
Sample M1 - Cementitious mortar below Robinson window.

The exterior of the Church is made up largely of mortar sample M1, which is a grey color and most likely contemporary probably dating to the 1981 restoration of the Church. The softer, lighter mortar found on the masonry wall beneath the porch on the Park Avenue elevation appeared to be older than the more predominant grey mortar. This assumption was based on its condition, softer lime mortar like appearance, and its sheltered position under the porch. A bedding mortar sample (M2) and a pointing mortar sample (M3) were removed from this wall.

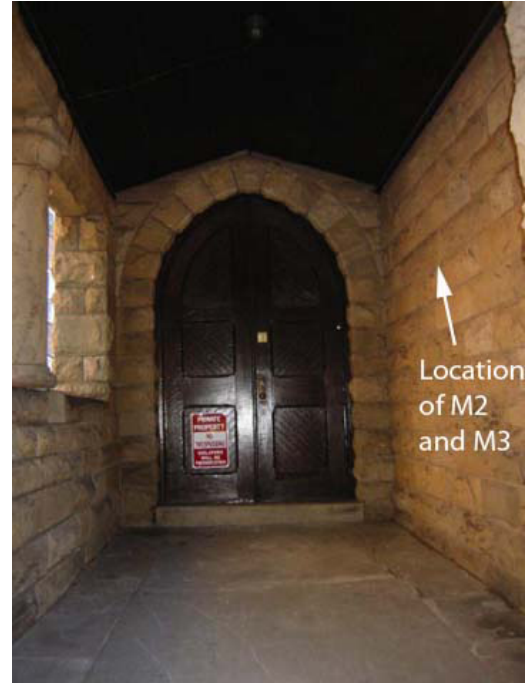
Samples M2 and M3 - The pointing and bedding mortar found under the portico on the Park Avenue elevation.

Historically bedding and pointing mortar were of the same mix, but while microscopic analysis of samples M2 and M3 showed the two mixes to be very similar, they are not the same. The bedding mortar is a lime based mortar, light grey in color. The pointing mortar contains cement in the mix and is a slight variation in color, light grey brown. Both samples showed the same red brown aggregate of crushed brick and/or rounded bits of sandstone and larger pieces of rounded quartz. The pointing mortar has the additional pieces of angular aggregate and grains of Portland Cement that were broken up during the grinding process but were never dissolved like the more soluble lime.

The bedding mortar is a lime mortar with a 1:3 ratio of lime to aggregate. The pointing mortar contained cement that was not completely broken down by the grinding process and acid dissolution used in gravimetric analysis. When the aggregate was sieved after the gravimetric analysis, some of the gravel in screens 8 and 12 contained what should have been smaller aggregate bonded together into larger pieces by cement. This may have thrown off the aggregate to cement to lime ratio. The pointing mortar may therefore be a Type O or N mortar. This mortar would contain 1 part cement, 1 to 2 parts lime, and 5 to 9 parts aggregate.

It is strongly recommended that any future repointing methods recreate these mortars, matching in color, texture, and type based on this analysis.

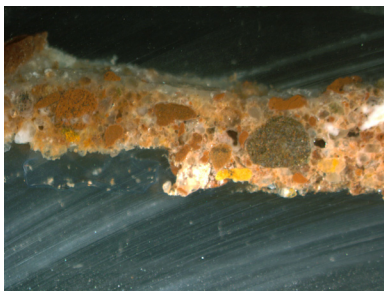
Cross section of M6, basement bedding mortar.

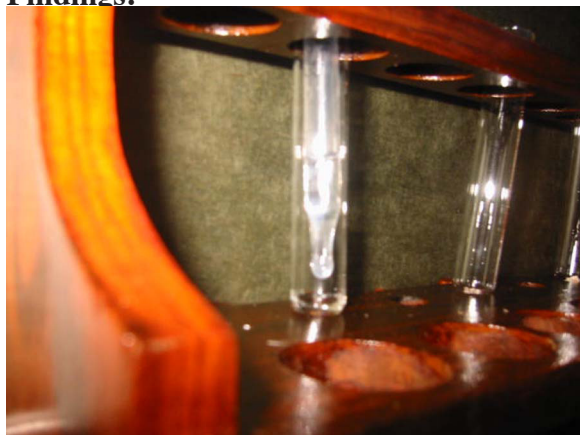
Positive for carbonates

The sample tested positive for carbonates as evidenced by photo 1. The dropper of 3% barium hydroxide ($\text{Ba}(\text{OH})_2$) turned cloudy when positioned over the effervescing sample.

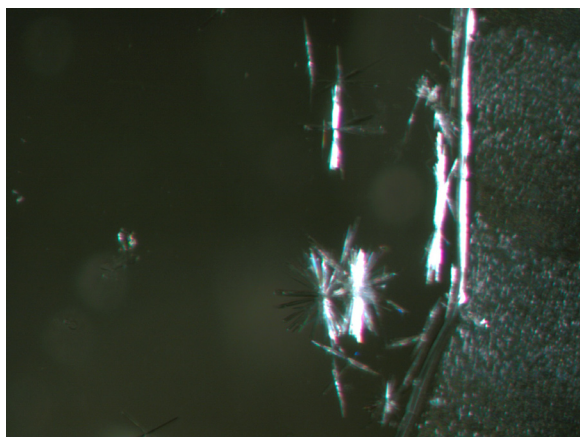
Positive for calcium

Photo 4 is a photomicrograph taken at 80x of the formation of gypsum needles. The formation of the crystals after the addition of 0.5M nitric acid (HNO_3) and 2M sulfuric acid (H_2SO_4) proved the existence of calcium.

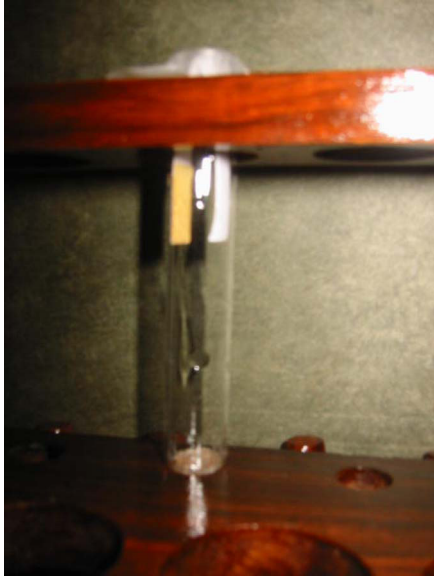
Negative for chlorides

Photo 2 shows the test for chlorides. The pH indicator strip was left in position for 5 minutes. The lack in color change of the strip showed that an acidic volatile gas was not created with the addition of 18N sulfuric acid (H_2SO_4), Thereby showing that chlorides are not present.

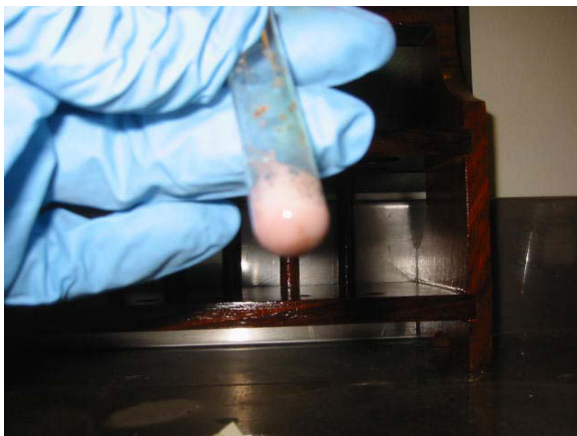
Negative for sulfates

Photo 3 shows the negative result of the nitrate test. A red/pink haze was the result of the addition of 18N sulfuric acid (H_2SO_4) and Iron(II) sulfate (FeSO_4).

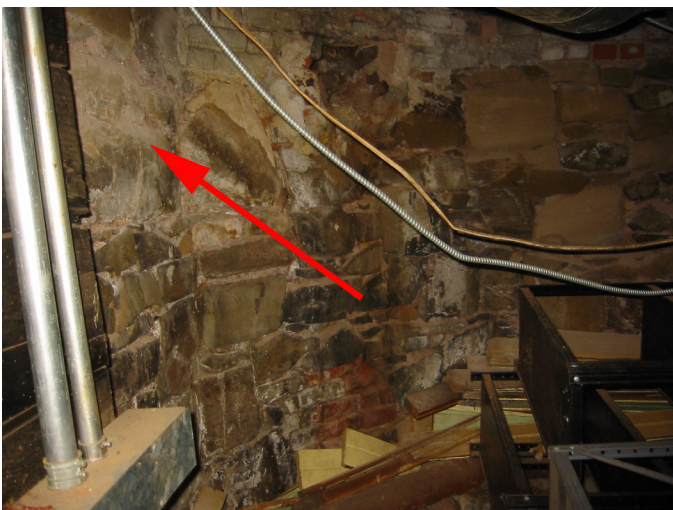
The presence of calcium (Ca^+) and carbonate (CO_3^{2-}) in the sample suggest that calcium carbonate (CaCO_3) is the efflorescence seen at 4'6". This salt is found in a number of building materials, including calcareous stone (such as limestone and marble), and mortar components such as lime and cement. The calcium carbonate can be leached out of the masonry by mildly acidic moisture. This moisture could come from acid rain, or be absorbed from the ground below the structure. In order to prevent further efflorescence, and to create a proper plan of action for the removal of the calcium carbonate crust found in the basement the origin of the mineral and the movement of moisture must be better understood. Further testing is needed as recommended below.

Efflorescence found found in basement

The mortar is certainly a possible source for the calcium carbonate, but the composition of the building stone must be identified as well in order to determine if its' chemical composition has played a roll in the formation of the efflorescence. This can be done through petrographic analysis by a trained professional.

The two main potential sources of moisture are acid rain and rising damp. Rain is naturally mildly acidic, but rainfall from around the church may be tested to see if the pH is lower (more acidic) than average. The ground water may also be tested, as well as the soil. Soil type should also be noted at that time to indicate how moisture might move through the local soil.
